# **MANDATORY**

This service bulletin is applicable for all Aviation Artur Trendak rotors.

Rotor under 1000 hours work - every 25 hour inspection.

Rotors above 1000 hours work – replacement.

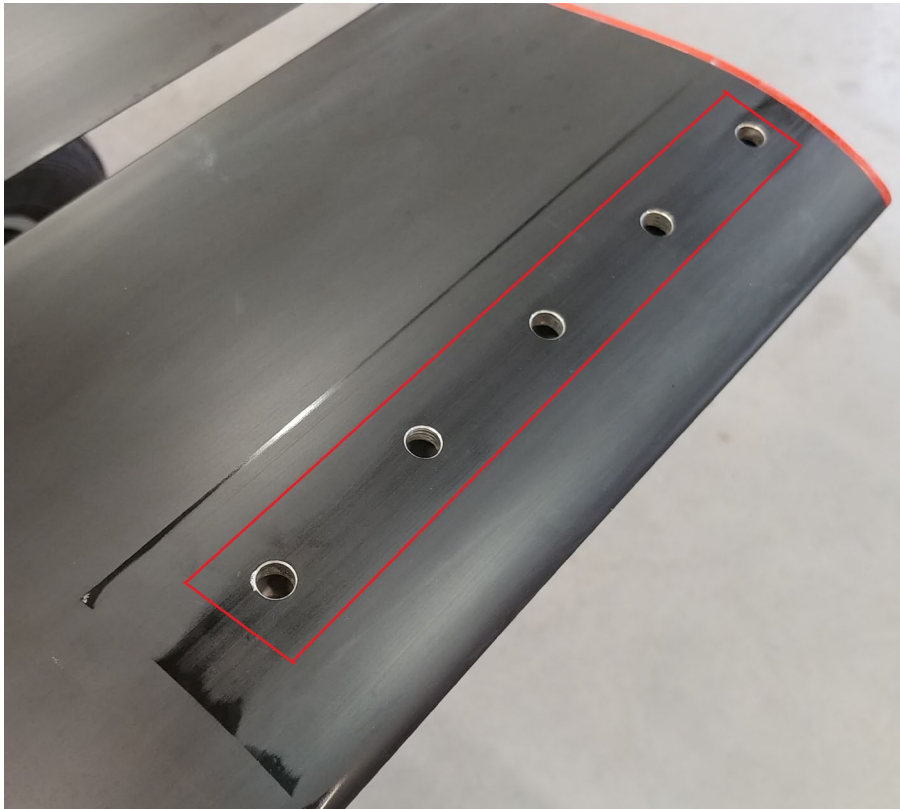
Fig. 1

- 1) Remove rotor from the gyro.
- 2) Unscrew the blades and sockets from the hubbar.
- 3) Carry out a visual inspection of the blades around the holes (fig.1, fig.2) that attach it to the hubbar. Look for scratches, chafing, cracks or other signs of damage. In case of doubt, contact Aviation Artur Trendak company.

- 5) If any scratches, chafing, cracks or other signs of damage or permanent deformations are found on blades, the gyrocopter can not be operated! Please immediately contact with manufacturer Aviation Artur Trendak.**

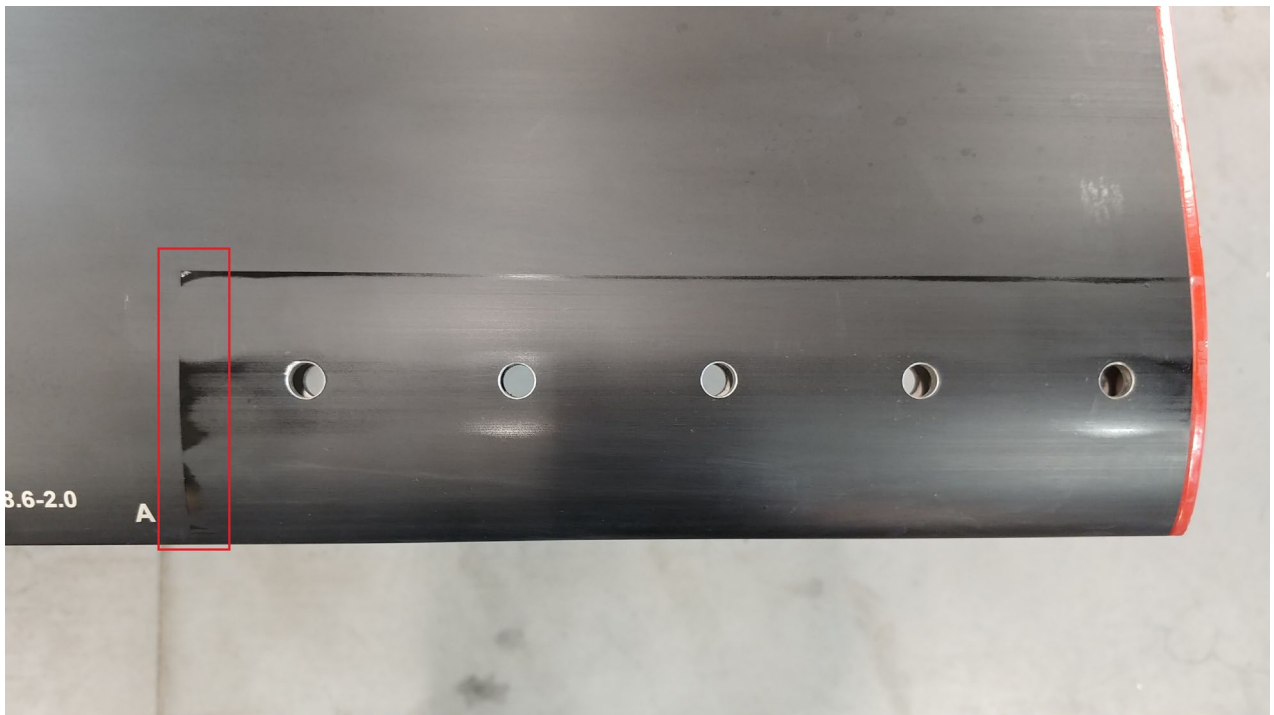
Fig. 3

- 4) Carry out a visual inspection of the blades near the end of the hubbar (fig.3, fig.4). Look for scratches, chafing, cracks or other signs of damage. In case of doubt, contact Aviation Artur Trendak company.
