# **MANDATORY**

## **SUBJECT**

Bowden flexible cable holder replacement.

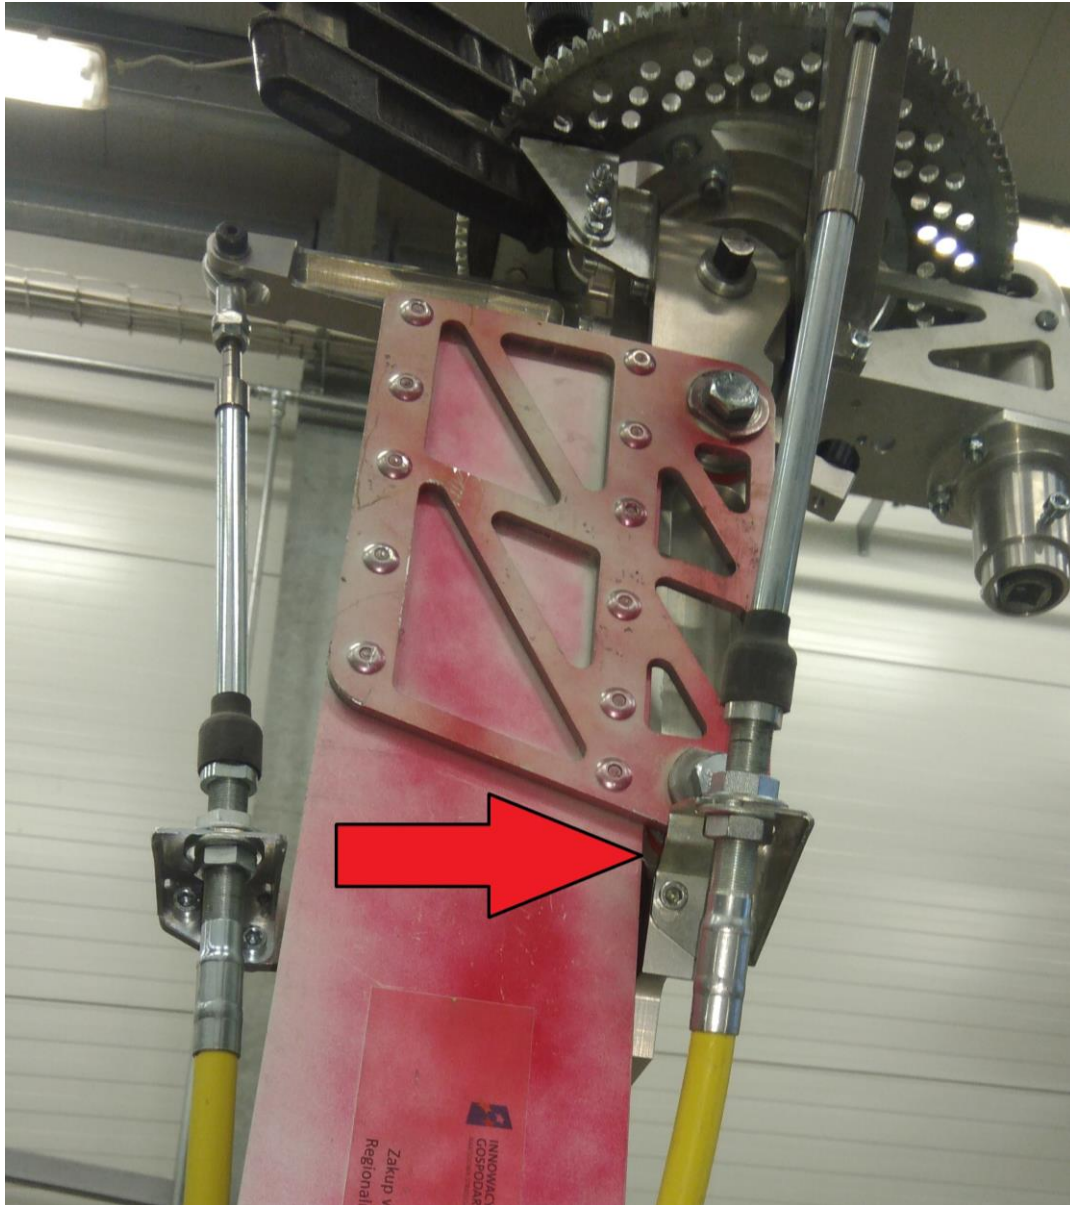
Fig. 1

- 1) Check the holder in gyrocopter. Holder to be replacement is shown on pictures below [Fig. 1] and [Fig. 2].

There is one main difference between these holders: the new one has reinforcing rib.

**Holder without rib have to be immediately replaced.**

- 2) There is no need to implement this bulletin If the gyrocopter has the new holder with reinforcing rib.
- 3) In case of an holder without rib, please check it before and after every flight.  
**If any crack or permanent deformations are found, the gyrocopter can not be operated!**
- 4) If the gyrocopter has holder without reinforcing rib please immediately contact with manufacturer Aviation Artur Trendak for further information: service manual and spare parts.

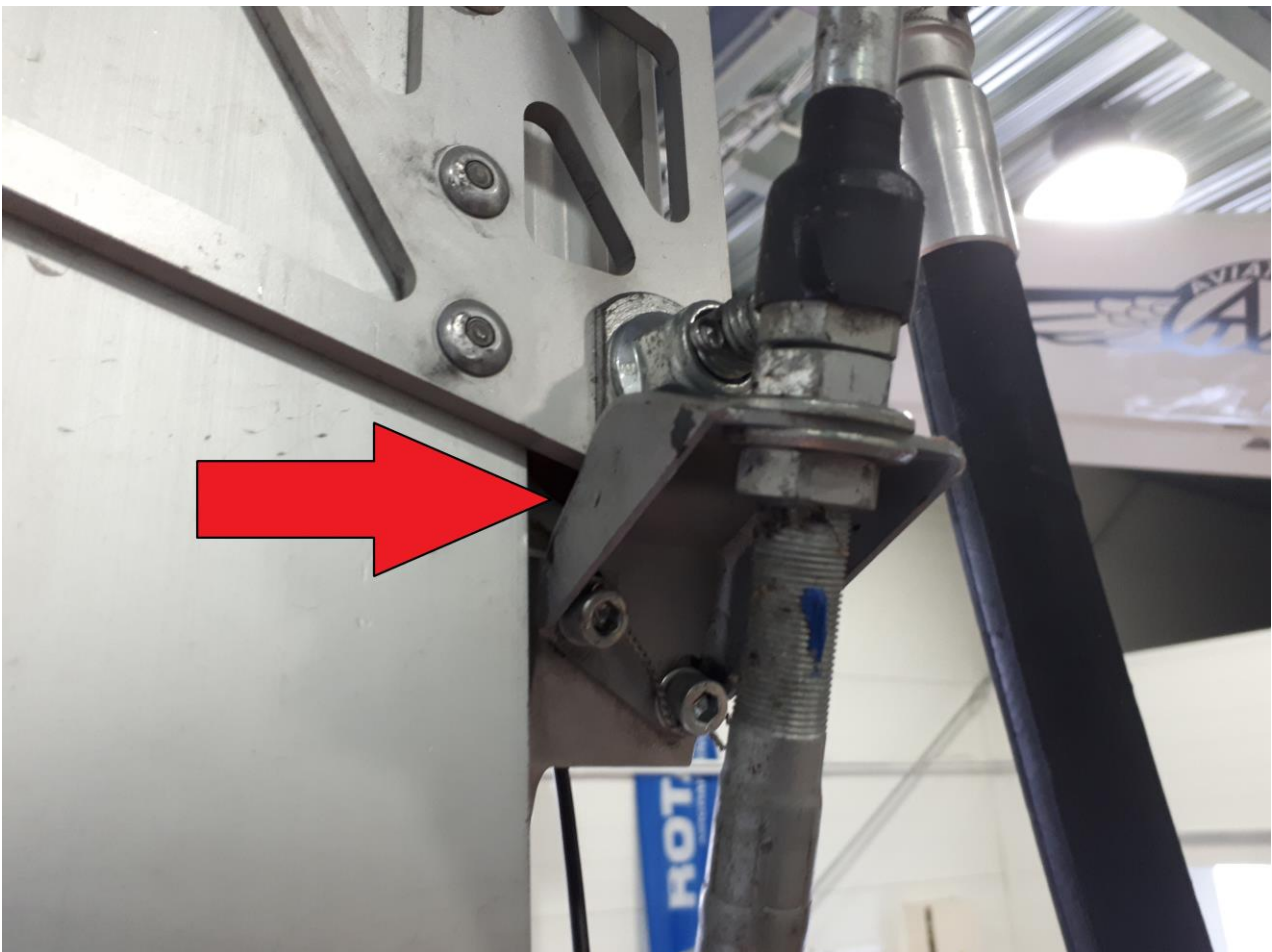
Fig. 3

The new, improved holder are on the following figures [Fig. 3] and [Fig. 4].
