MANDATORY

19.05.2021

Bendix mounting

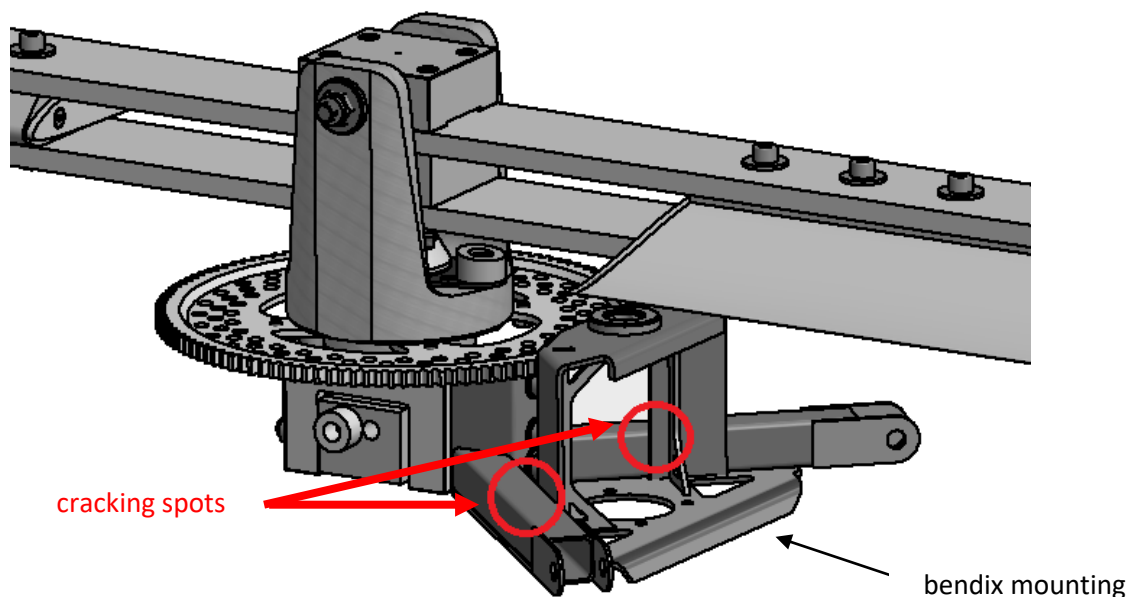
1. Before and after every flight inspect (visually or with a magnifier) the bendix mounting for cracks or other deformations. The marked spots (picture 1, picture 2) should be thoroughly checked, as they are particularly prone to cracking. If any abnormalities detected, the gyrocopter must be grounded. Contact the manufacturer to specify the way to restore airworthiness.

Picture 1. Cracking spots on the bendix mounting.

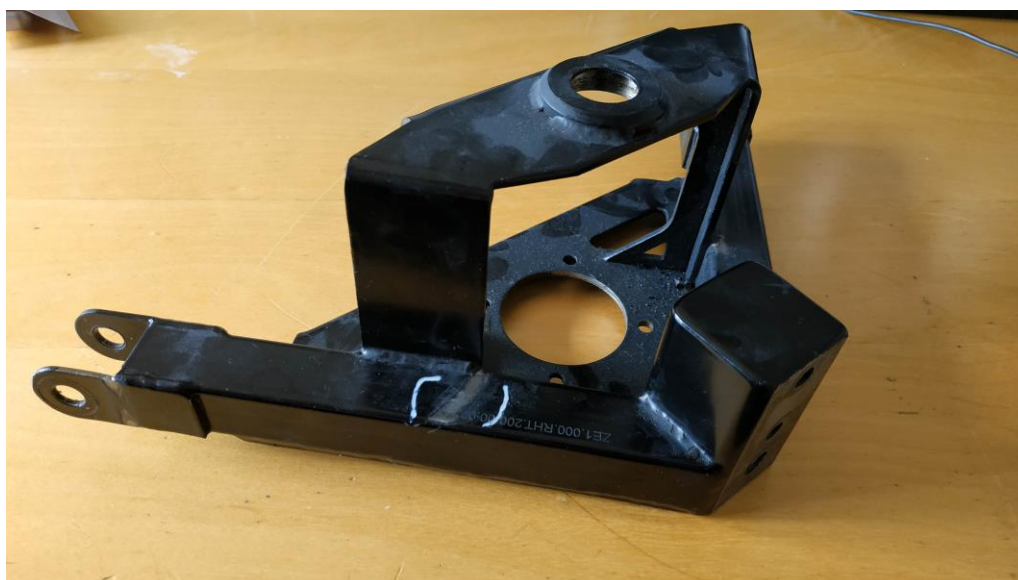
Picture 2. Photo of the bendix mounting.
