This service bulletin is applicable for all Tercel's gyrocopter.

Bowden flexible cable holder replacement.

<b>SERVICE BULLETIN</b>	30-07-21
		No. 01-21

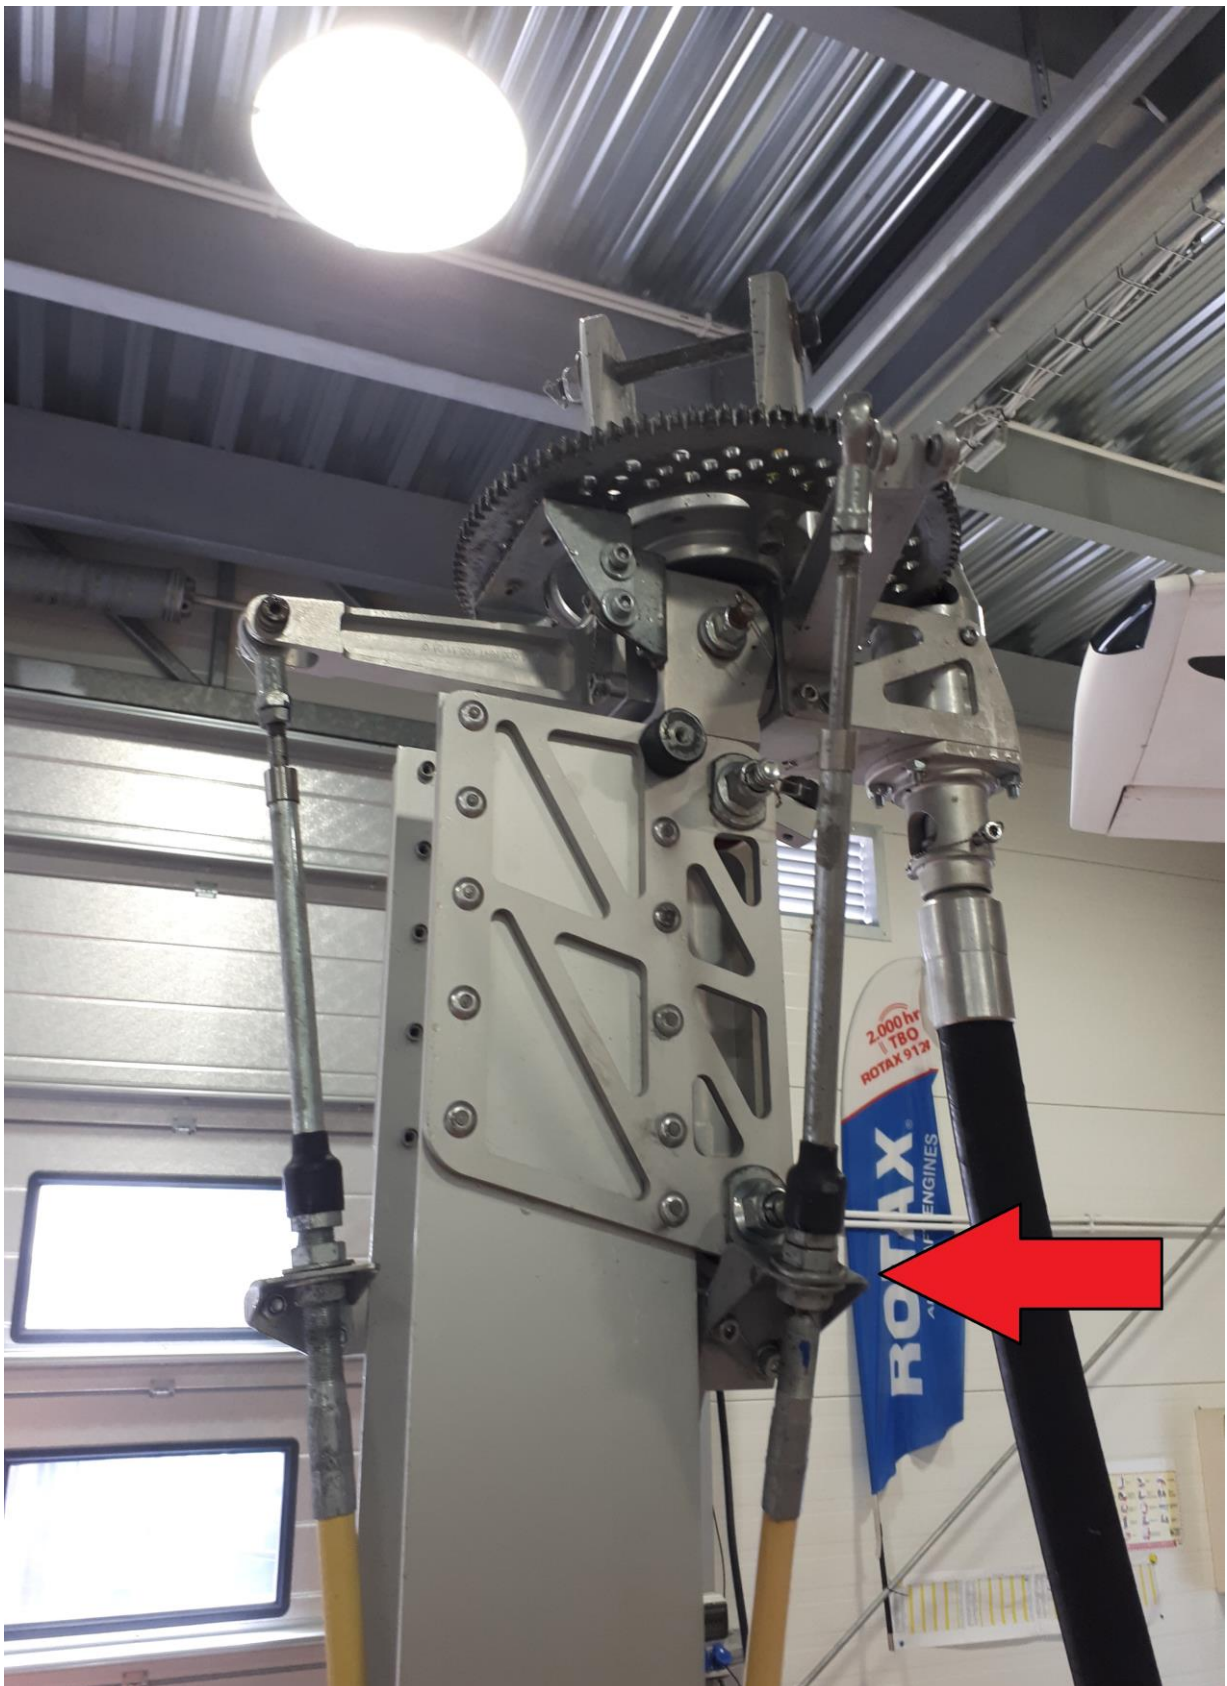
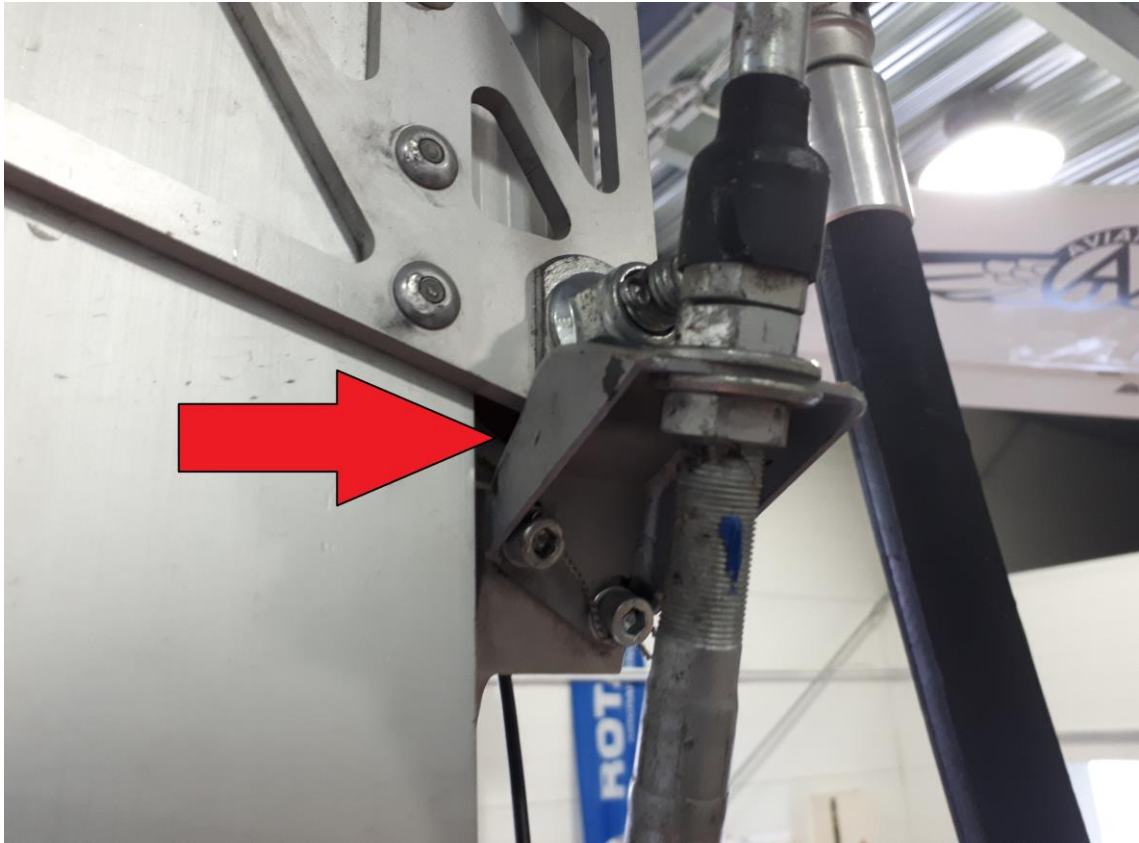
- 1) Check the holder in gyrocopter. Holder to be replaced is shown on pictures below [Fig. 1] and [Fig. 2].

There are two main differences between these holders: the new one has reinforcing rib and additional hole.

**Holders without reinforced rib and additional hole have to be immediately replaced.**

- 2) There is no need to implement this bulletin If the gyrocopter has the new holder with reinforcing rib.
- 3) In case of an holder without rib and additional hole, please check it before and after every flight.  
**If any crack or permanent deformations are found, the gyrocopter can not be operated!**
- 4) If the gyrocopter has holder without reinforcing rib and additional hole please immediately contact with manufacturer Aviation Artur Trendak for further information: service manual and spare parts.
